Quest Engineering & Failure Analysis, Inc. www.quest-engineering.com

Re: FR26 Report

File: Bryson Accident

Quest No: 10519

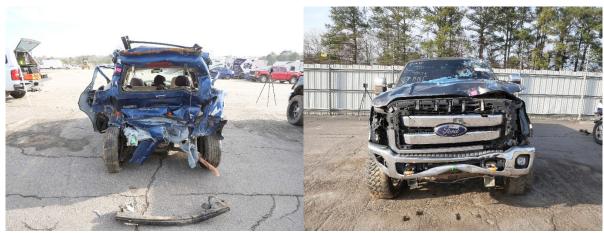
Figure 1: Match points with brightly colored tape

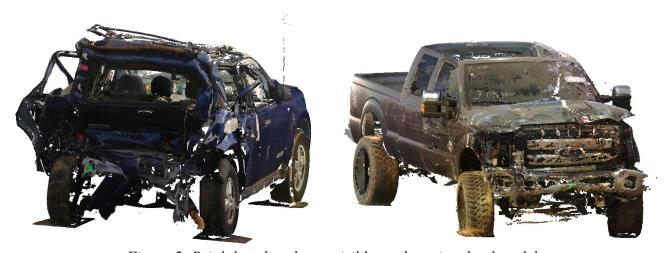
Figure 2: Brightly colored tape visible on the point cloud models

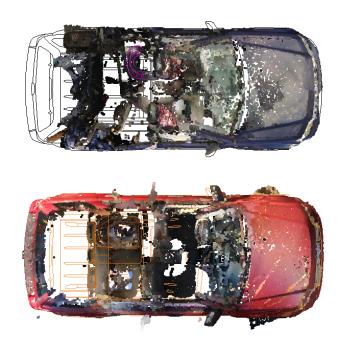
The rear seat of the Escape had been displaced forward significantly. To measure the change in forward distance that the seat had been displaced, the roofs of the subject Escape and the Escape exemplar scans were cropped, revealing the interior of the vehicles. Because the rear seat moved forward, the child seat also moved forward. The exemplar car seat was scanned in the exemplar Escape; therefore, it was visible in the cropped scan. The accident car seat no longer fit in the subject Escape. Using a 3D editing software, CloudCompare, the exemplar car seat was placed in the scan of the accident Escape based on DOA photos. This model was imported into AutoCAD and the roof was cropped, revealing the difference in the forward distance of the child seat. The movement of the head rest area and the bottom of the seat were compared (*Figure 5*).

Figure 5: Rear seat and child seat change in position

- The Escape felt a maximum of near 23.6 g's.
- The left rear occupant position had approximately 1.5 feet of forward static shift and the dynamic shift of the head rest area of the child's seat was approximately 2 feet.

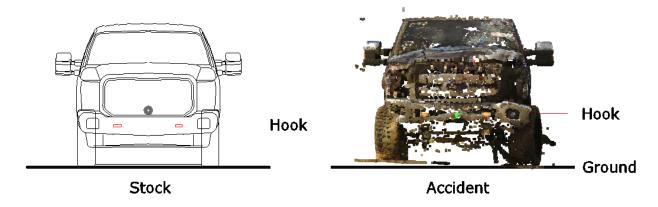
The difference in height of the F250 was determined by using side views of the F250 in AutoCAD. The scan of the exemplar (stock) F250 was drawn and the subject F250 was drawn. This revealed the height difference between the stock and lifted F250 (Figure 6). This was also verified by using measurements of the subject F250 and comparing against the exemplar F250.

Figure 6: Stock F250 comparison to Accident F250

- The F250 was effectively lifted over 6 inches.
- In the subject accident the F250 bumper penetrated to beyond the original location of the child seat pushing the child seat's head rest area (Safety 1st logo) forward by over 18 inches to a post-crash rest location of 1.1 feet from the rear of the driver's static seat back location.
- Dynamic analysis and damage matching reveal that during the crash the F250 bumper penetrated 4.36 feet into the rear hatch trunk and rear seat position areas, pushing the child seat's head rest area (Safety 1st logo) forward over 2 feet to a during-crash location only about 6 inches from the driver's static seat back location (top of the seat).
- Had the lift kit not been installed, the stock F250 would have interacted more directly with the stronger structural components of the Escape rear as opposed to the Escape hatch and pillars.

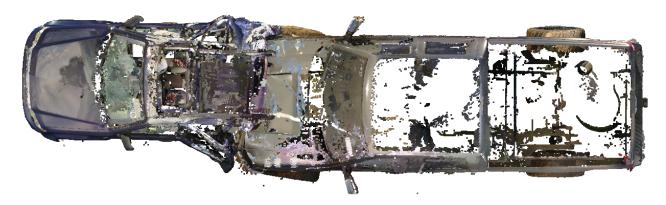
Figure 7: Maximum Engagement modeled in 3D

A gash on the Escape rear matched the geometry and dimensions of the SEAS bracket. At one of the vehicle inspections, an exemplar SEAS bracket was matched with the gash on the Escape's rear. The other SEAS bracket corresponded to the left rear tire of the Escape, which displayed contact damage. Additionally, by using the contact damage, the hood of the F250 impacted the D-pillars of the Escape and the right front tire of the F250 impacted the tailpipe of the Escape. This information was used to validate the maximum engagement of the F250 into the Escape.

A CAD comparison of the post-crash vehicle crush geometries to the deepest penetration match points revealed over ½ foot of dynamic rebound occurred. Thus, the Escape dynamic crush was determined through the comparison of known match points.

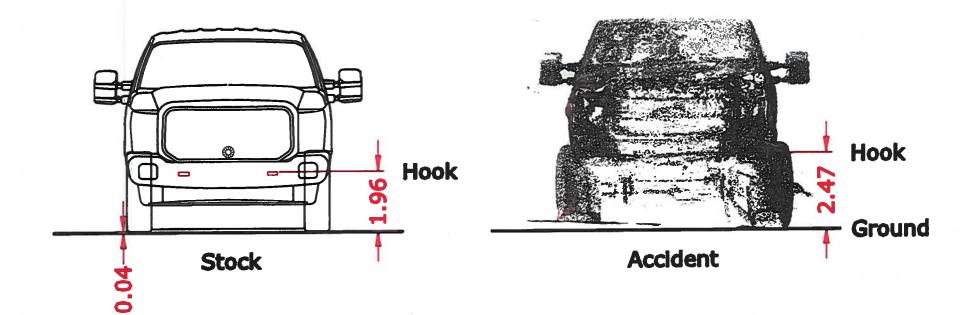
# 10519 Base Vehicle + Crush Level Scan

Frenzier Seen Paised 0.04" To account for Stock Tire Vifference.

Lift = 0.51'

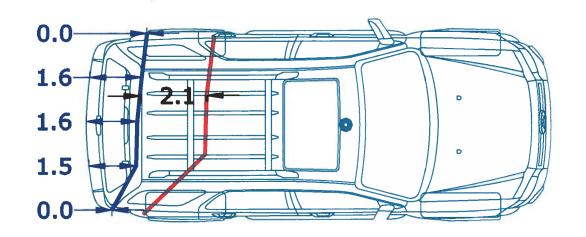
### 10519 Simulation @ 2.2' Above Ground

Red: Accident Damage
Blue: Simulation Damage

## $\Delta$ Crush $\approx$ -2.1 feet
